**SAFETY EVENT- MOISTURE AND
OIL INGRESS INTO BREATHING
APPARATUS
November 2018**

A case study into a safety event in Buckinghamshire Fire & Rescue Service involving the failure of a Breathing Apparatus cylinder charging facility

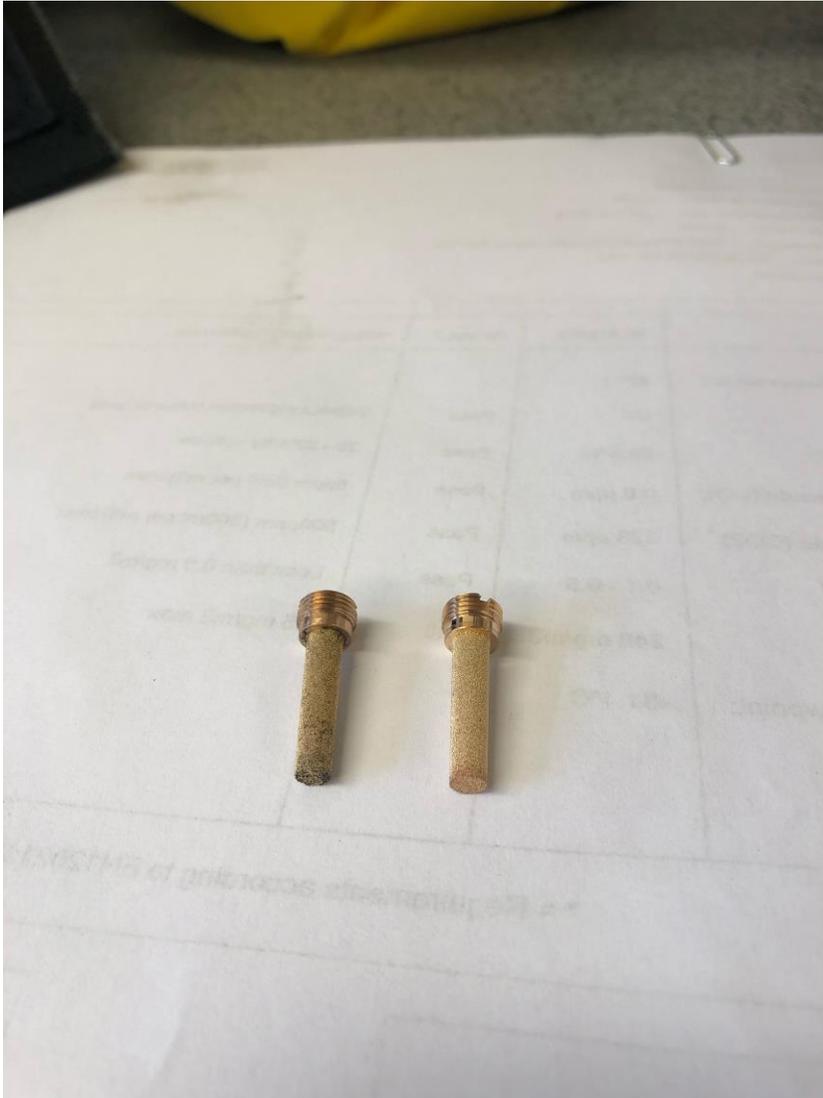
Evidence of oil contamination

- Sintered filter (left) from BA set which had failed a function and leakage test

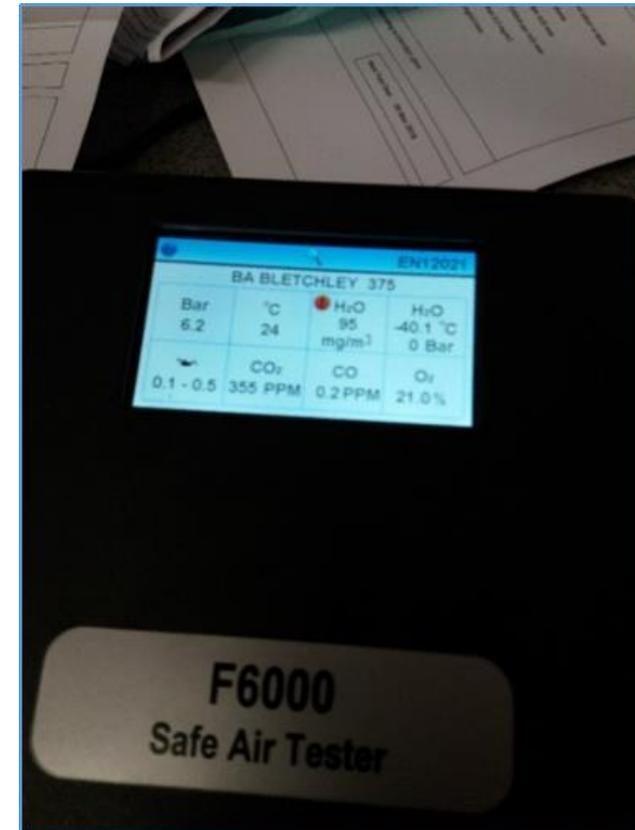
- Moisture content within the cylinder compressor should be filtered to below the Standard threshold of 35mg/M³. Lubricating oil should also be filtered to below a Standard threshold of 0.5mg/M³.
- High moisture levels can lead to freezing within the BA pneumatics, particularly around the pressure regulator and breathing valve assembly, increasing a risk of equipment failure.
- elevated oil content carries a risk of:
 - over-lubrication of moving parts,
 - an explosive mixture within the tertiary chamber of the pressure reducer (which is open to atmosphere)
 - degradation of the internal lining of pneumatic hoses over time.
 - Additionally, oil contaminate awould deliver an undesirable odour to the wearer.
